BHARATI
VIDYAPEETH'S
COLLEGE OF
ENGINEERING
KOLHAPUR

ENERGY AUDIT
REPORT

SEPTEMBER-2022

Upendra Deuskar & Associates, Kolhapur

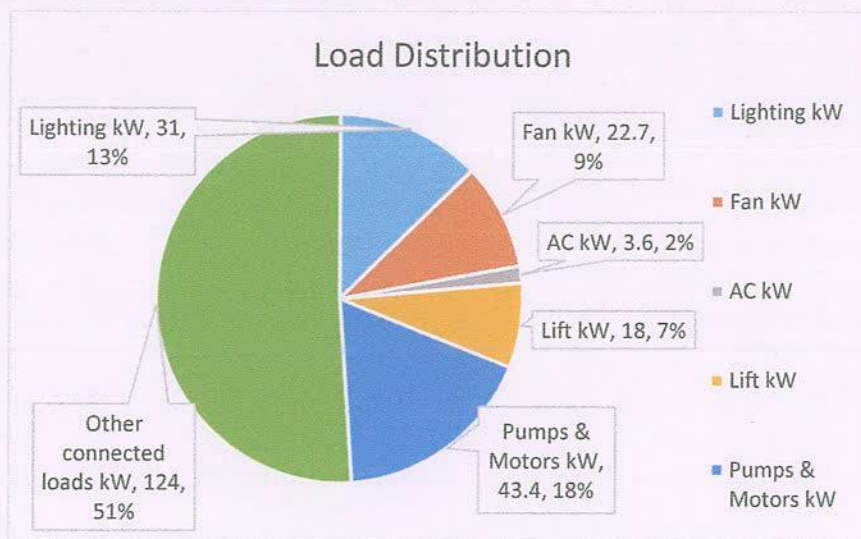
Pie Chart 1 Load Distribution

Load distribution for the college premise is represented below.

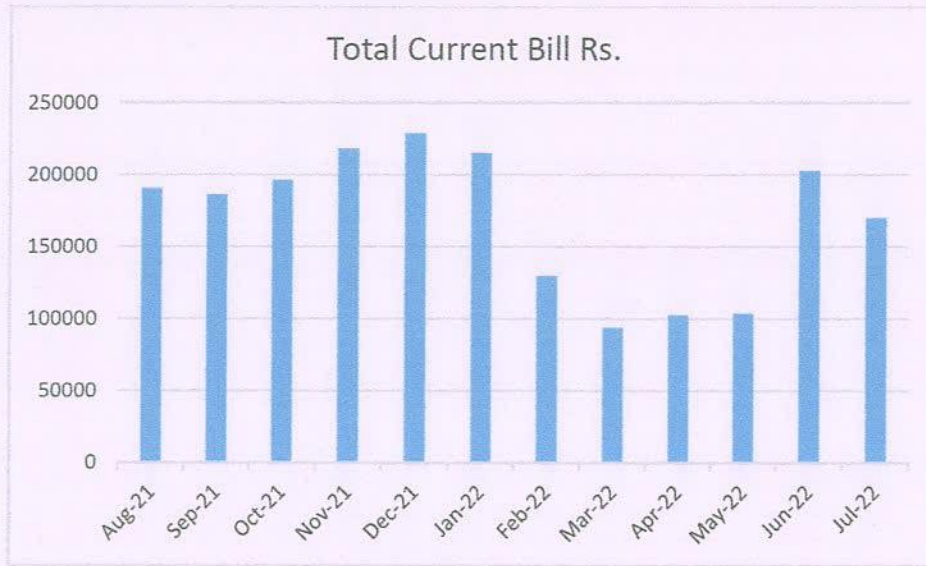
Figure 1. Electricity Bill Trend

Energy consumption, PF, MD recorded, billed demand, Excess Demand charges, PF penalty trends are represented in graphical format as below.

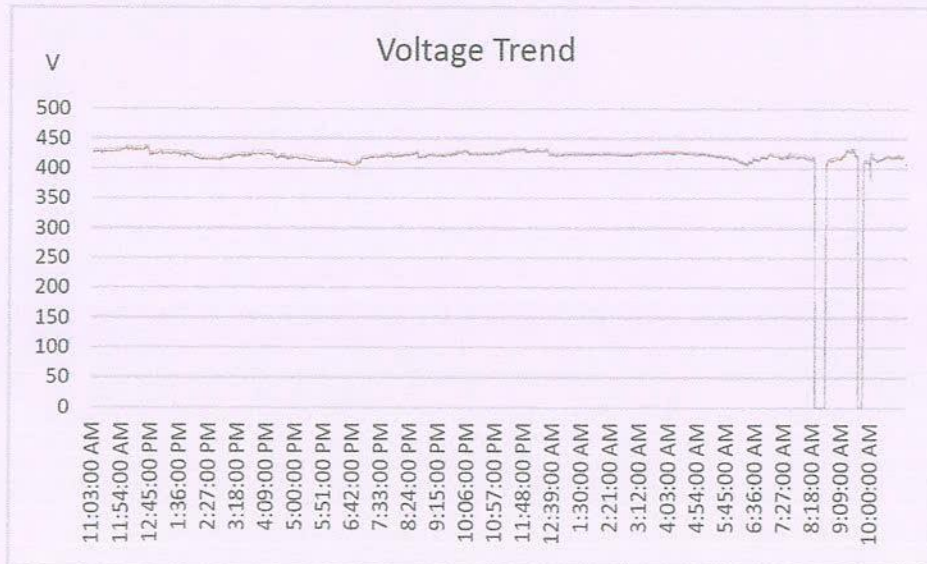
Figure5. Main Incomer Voltage Profile

Voltage, Current, Power and power factor profile with other electrical measurements were carried out at the main incomer coming of installed Transformer using a Power Quality Analyser. The profiles for the same are given below.

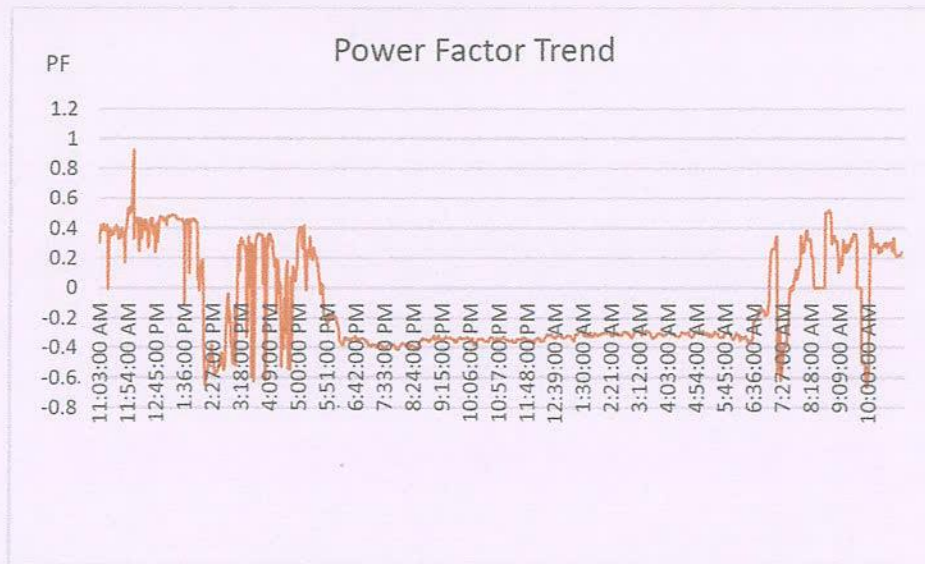
Figure9. Main Incomer Power Factor Profile

- It is observed that negative PF occurring and the issue need to be resolved on immediate basis.

- Negative power factor occurs when electrical power generated from the load and flows back towards the source.
- Another reason for occurring negative power factor is when in an electrical circuit both inductive and capacitive load is connected. In this case, if the reactive part of the consuming power is more capacitive than inductive.

- Negative Power Factor causes the terminal voltage across the load to rise above its open circuit value. This may damage the voltage-sensitive load.
- Negative power factor can damage the power generating devices such as solar panels, generators, etc.

- As there are two reasons for the occurring negative power factor, there also two methods for improvement.
 - If the negative power factor occurs due to power flow in the opposite direction, then it should be stopped. A PN Junction diode can be used to stop power flow in reverse direction.
 - Another way to improve the negative power factor is, controlling reactive power. If the power factor is lagging then it is to be added to the load to compensate for the power factor. If the power factor is leading then reactive power is to be absorbed.

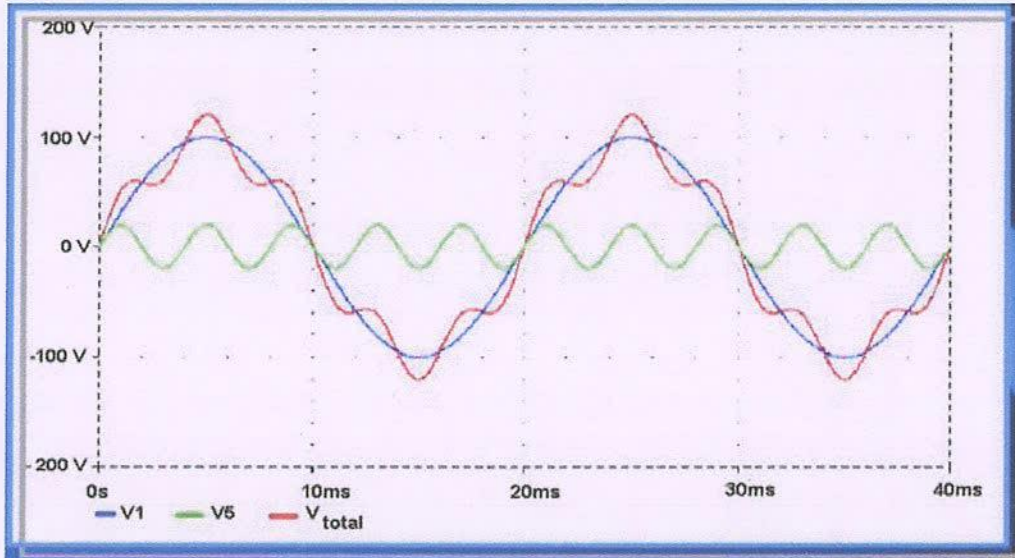
Figure10. Harmonics

Harmonic of a wave is the wave which has frequency as the positive integer multiple of the frequency of the original wave, known as the fundamental frequency.
